**NASA Contractor Report 180809**

**EVALUATION OF COATED COLUMBIUM TEST  
PANELS HAVING APPLICATION TO A  
SECONDARY NOZZLE EXTENSION FOR THE  
RL10 ROCKET ENGINE SYSTEM; PARTS I  
AND II**

**FINAL REPORT**

*Pratt & Whitney  
Government Engine Business  
P.O. Box 109600  
West Palm Beach, Florida 33410-9600*

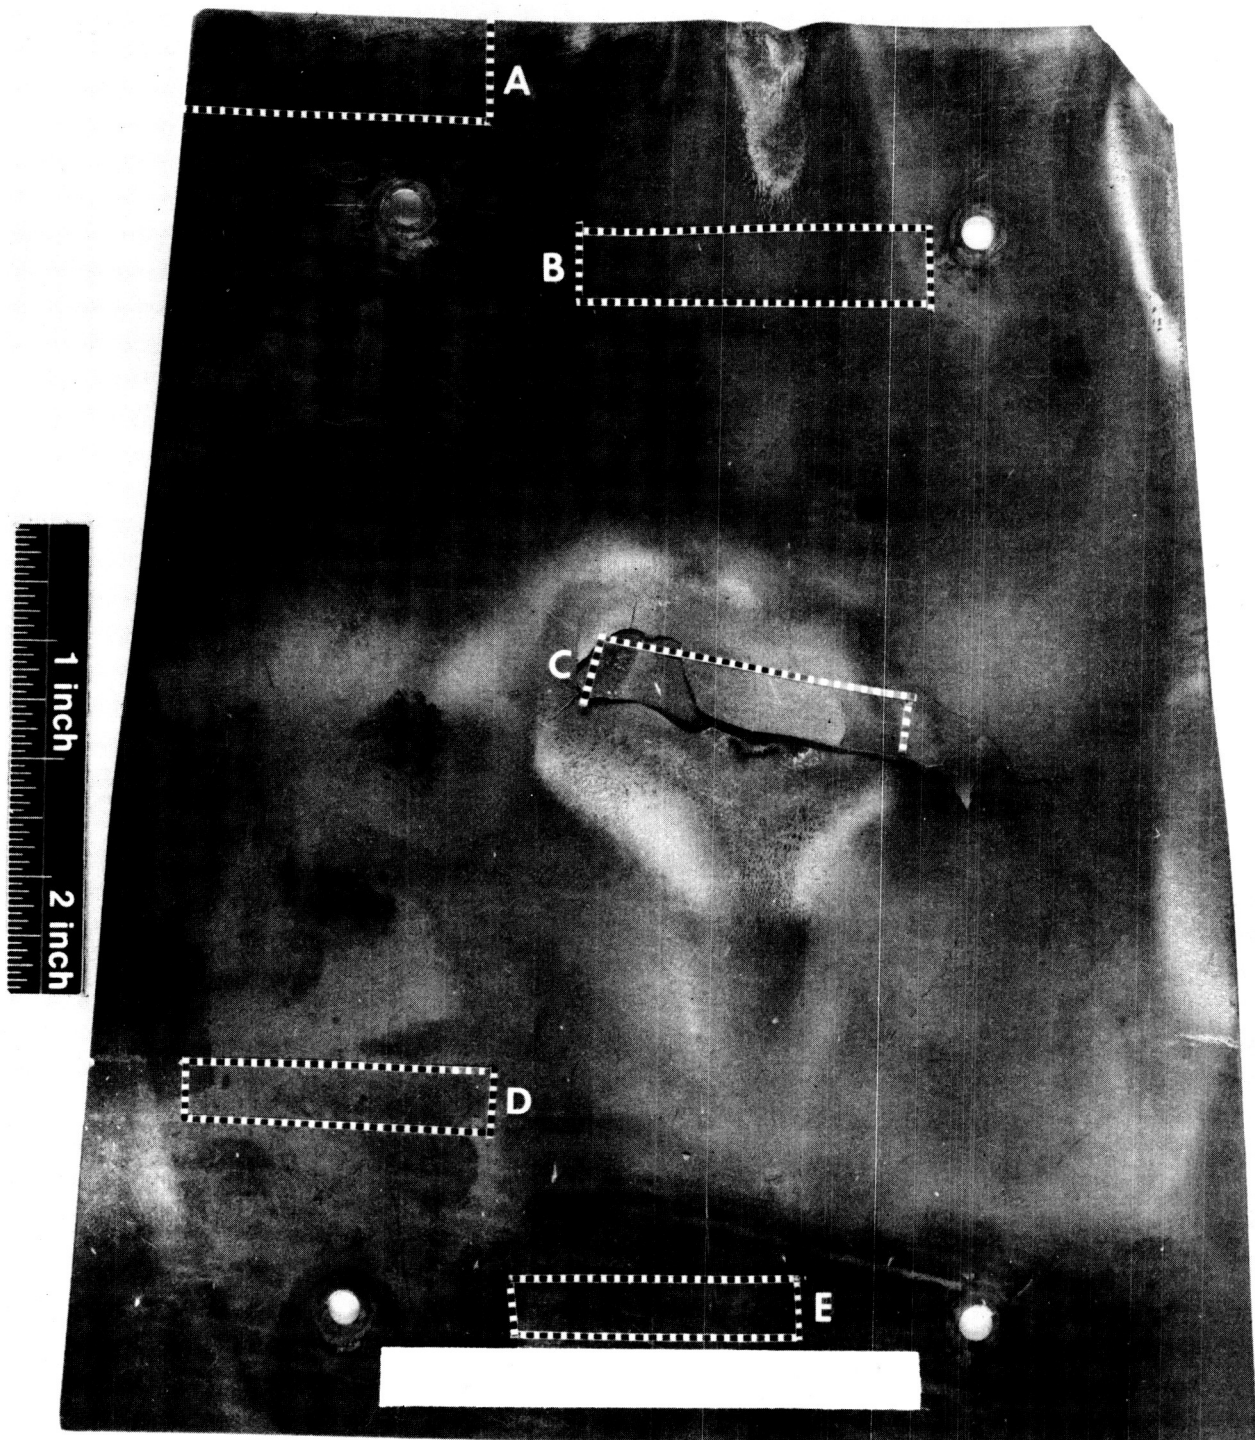
*Figure 3-1. Gas-Path Environment Side of Uncoated C-103 Test Panel with Sectioning Pattern — Run Time: 1203 seconds — Start/Stop Cycles: 6*

Visual inspection of the uncoated C-103 panel (Figures 3-1 and 3-2) showed excessive warping near the center of the panel, a large circumferentially oriented crack associated with the warping, and white oxidation products. More oxidation was associated with the chamber (capsule) side of the panel than the gas-path (flame) side of the panel. A corner of the panel was chipped during removal from the engine indicating the brittle nature of the tested C-103 panel.

All microhardness measurements for the uncoated panel are documented in Figure 3-10. Region A was located near the inlet plane of the nozzle extension. No significant change in microhardness was noted for Region A. Region B appeared to be below a hot streak as the oxidation pattern on Figure 3-1 indicates. Microhardness measurements reflected this observation. The hardness profile varied from about 170 VHN in the center to about 700 VHN near both surfaces. Region C, which visually showed the most oxidation, had a hard central core (440 VHN) as well as a hard perimeter (600 VHN). Regions D and E were similar to region B with a ductile core (VHN 170) and a hard perimeter (700 VHN and 800 VHN respectively).

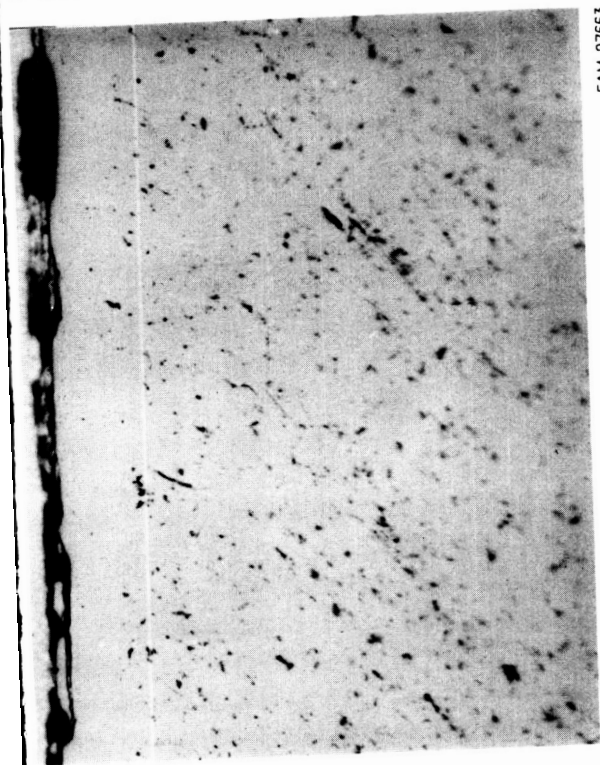
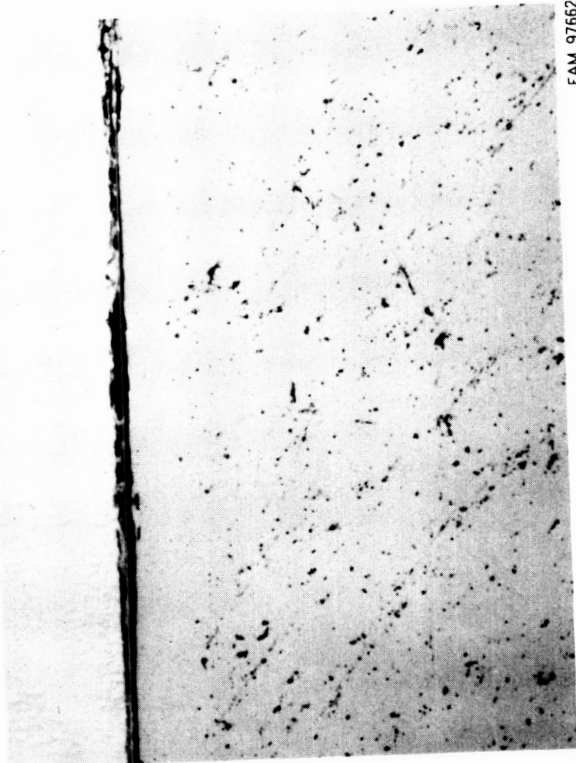
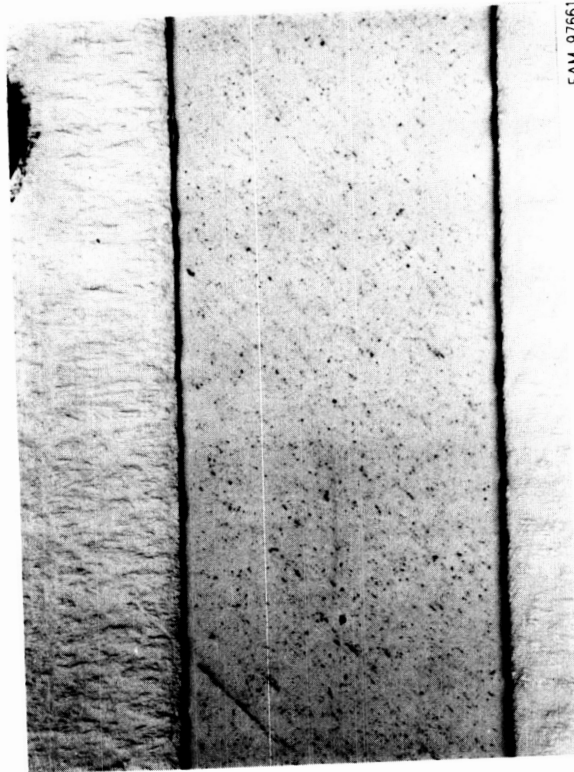
Figure 3-3. Uncoated C-103 Microstructure at Region A (S/N 60210-3) — Run Time:  
1203 seconds — Start/Stop Cycles: 6

The panel was sectioned in the pattern shown in Figures 3-1 and 3-2. Metallographic examination concurs with the visual observations. Figures 3-3 through 3-7 document typical microstructures of the gas-path side, the chamber side, and the panel core. A line-scan of oxygen x-rays vs intensity (Figure 3-8) illustrates the presence of oxygen in the surface scale and in grain boundary precipitates. In general, the oxide on the chamber side was thicker than the oxide on the gas-path side. An obvious change in microstructural features was noted in most sections near the midpoint of the panel thickness. The ductile characteristics of the polished core (excessive scratches) resembled the ductile characteristics of polished, virgin C-103. The polished surrounding material displayed signs of brittleness which is characteristic of oxygen embrittled C-103.

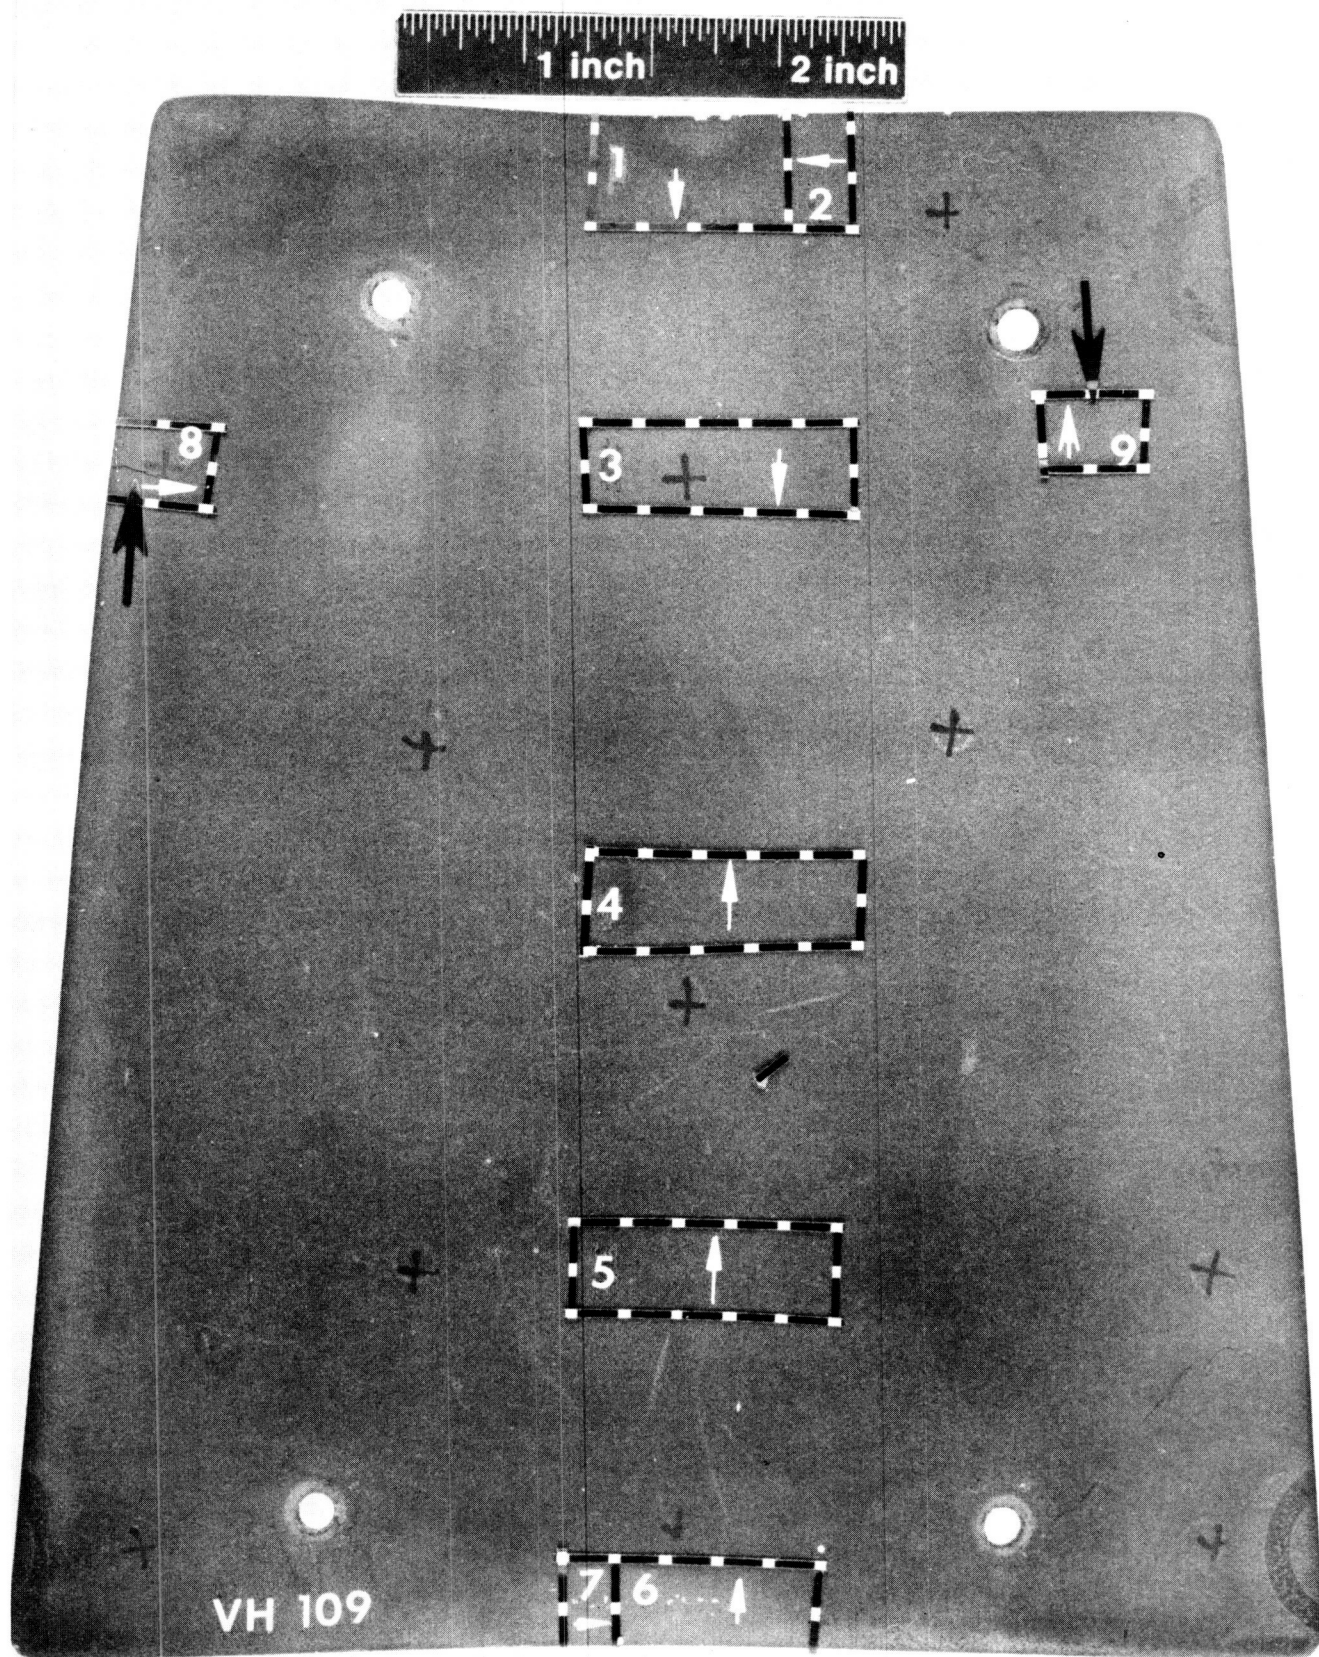
*Figure 3-16. Sectioning Pattern of Flame-Side VH-109 Coated C-103 Test Panel — Run Time: 4451 seconds — Start/Stop Cycles: 23*

From Part I of this report, the initial coating and substrate thicknesses were 4.1 and 10.5 mils respectively. Figure 3-16 displays the sectioning pattern used to document the thicknesses shown in Figure 3-17. More coating thickness variation was noted after the engine test. The post-test thickness averaged 4.8 mils with a standard deviation of 0.7 mil. Prior to the test, the thickness was documented at 4.1 mils with a standard deviation of 0.4 mil<sup>3</sup>.

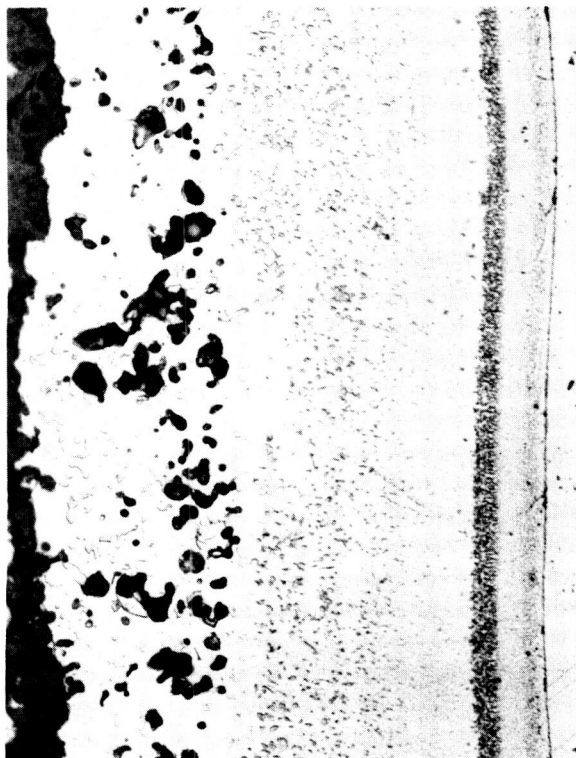
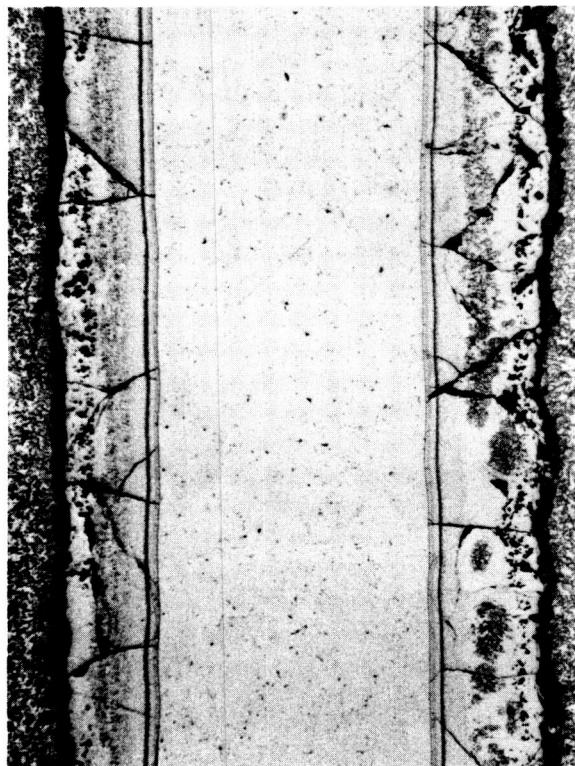
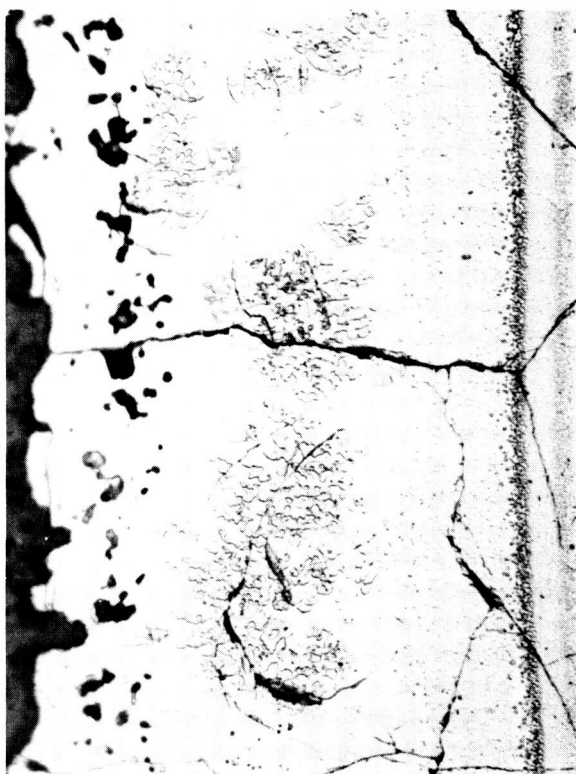
Figure 3-18. VH-109 Coating Microstructure at Region 1 (S/N 60321-1) — Run Time: 4451 seconds — Start/Stop Cycles: 23

Review of the microstructures, progressing from the inlet plane of the extension to the exit plane of the extension, revealed only small microstructural changes (Figures 3-18 through 3-22). Two differences, noted from the as-received microstructure, were the distribution of secondary phases and an increase of porosity in the first one-to-two mils of coating. The second phase distribution transformed from large intermittent precipitates to a continuous population of fine particles. Porosity in the first one-to-two mils of coating was more predominant after the engine test. No logical pattern was evident to explain the occurrences of increased porosity .

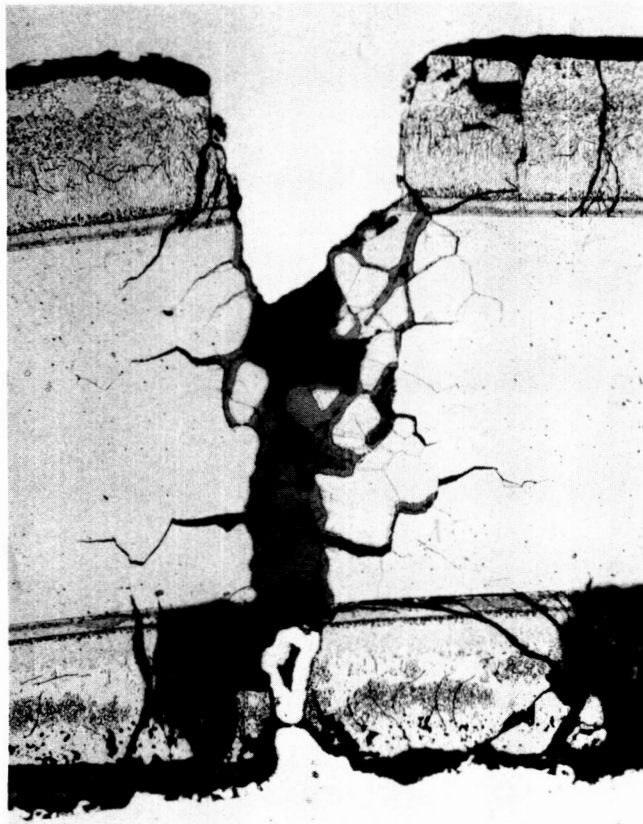
Two anomalies were associated with this panel, a crack caused by warping and a pinhole flaw. The cross section of the crack in this panel was typical of exposed C-103 (Figure 3-23). An oxygen embrittled zone with grain boundary oxides were associated with the crack. The pinhole flaw was initiated by mechanical damage prior to the engine test, not engine operation. The cross section of the flaw indicates that the C-103 substrate was locally bent (Figure 3-24). The damage caused a break in the coating which exposed the substrate to the oxidizing environment.

*Figure 3-23. Cross Section of Crack on VH-109 Coated C-103 Test Panel — Run Time: 4451 seconds — Start/Stop Cycles: 23*

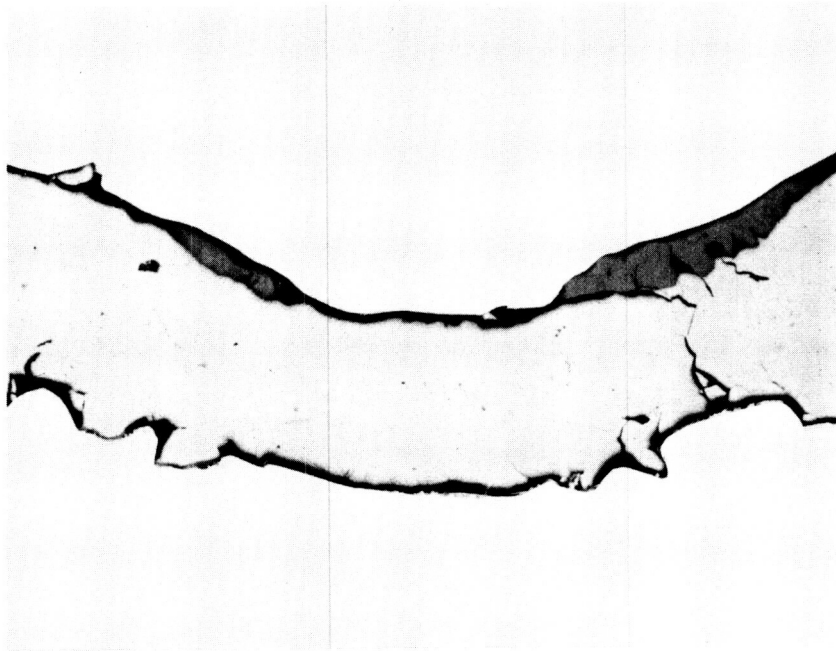
*Figure 3-24. Cross Section of Pinhole Coating Failure Illustrating the Mechanical Damage That Led to C-103 Oxidation*

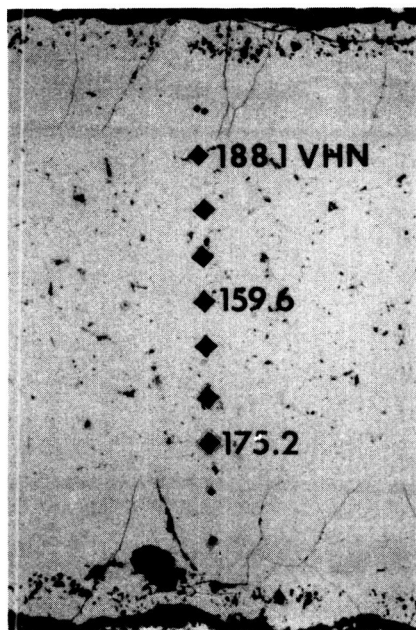
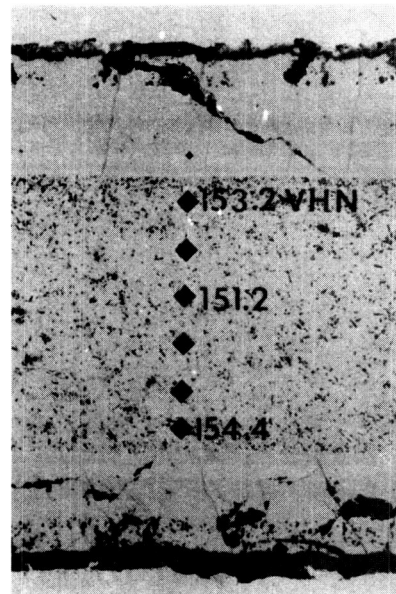
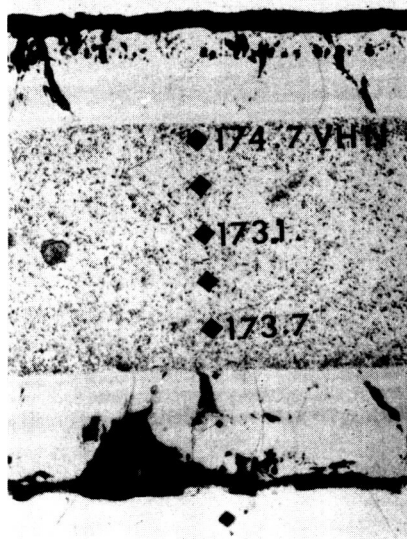
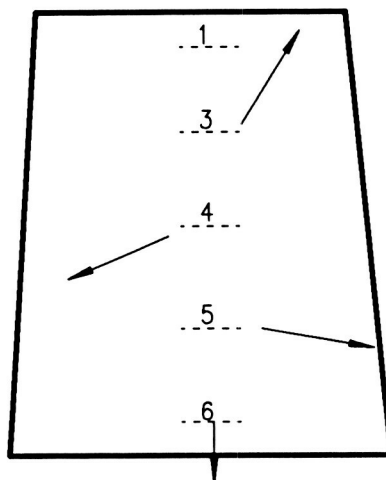
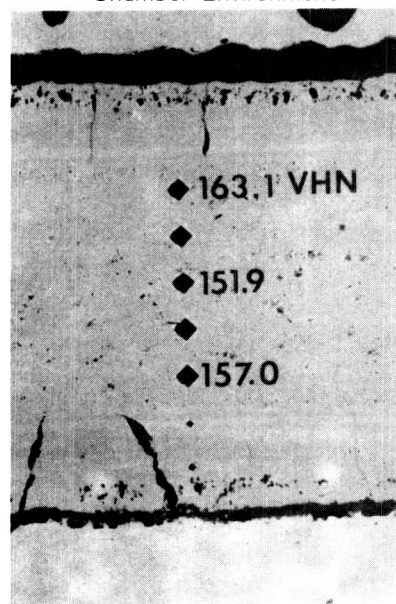
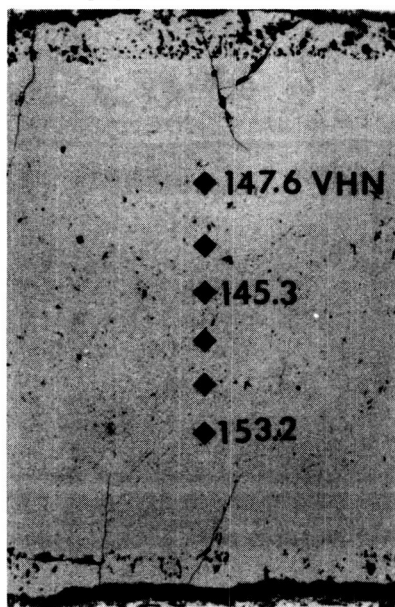
The C-103 substrate appears to have been protected from the embrittling effects of H<sub>2</sub> and O<sub>2</sub> gases. No significant change in microhardness from virgin C-103 was detected (Figure 3-25). The virgin material had a microhardness of about 160 VHN while the tested VH-109 coated C-103 microhardness ranged from about 150 VHN to 190 VHN. Region 1 had measurements that were significantly above the virgin C-103 values. This minor variation may be due to solid solution strengthening caused by the inward diffusion of coating elements.

Figure 3-25. Microhardness Measurements Through the Thickness of VH-109 Coated C-103 Test Panel — Run Time: 4451 seconds — Start/Stop Cycles: 23

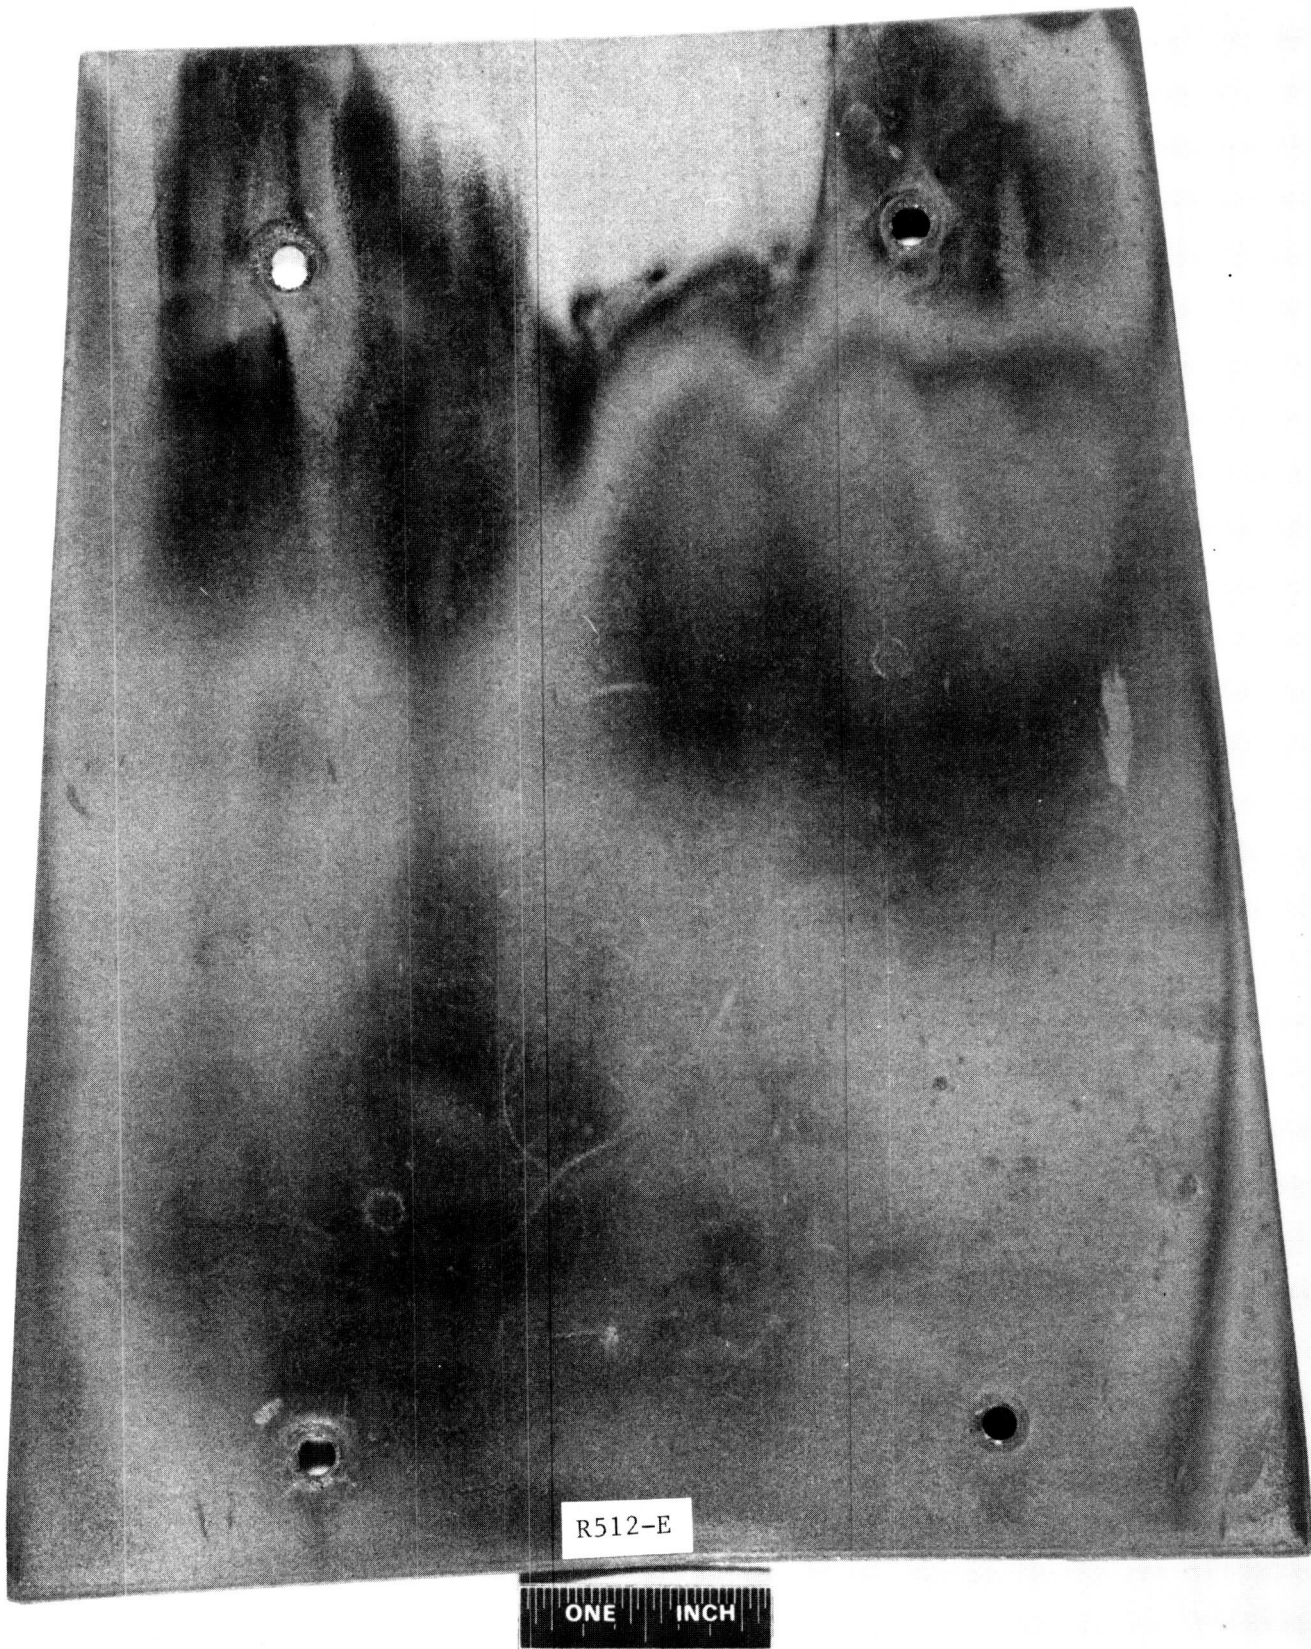
Unlike the VH-109 panel, the R512-E panel had various rainbow color patterns on both the gas-path and chamber side environments (Figures 3-26 through 3-29). The colors varied from blue to gold. A region near the inlet plane of the nozzle extension appeared to be unaffected by engine operation and remained grey. When the panel was rotated to examine the downstream view of the exhaust gases, a pattern that matched the cooling tube spacing was observed (Figure 3-27). Warping of the panel was minimal. However, a crack was noted in one of the support bracket legs (Figure 3-28). This crack may have relieved stresses which minimized the amount of warping on this panel. Examination of the exit plane edge of the panel revealed a small chip in the coating on the chamber side (Figures 3-29 and 3-30). No significant evidence for Cb oxidation was associated with the chip.

*Figure 3-26. Gas-Path Environment Side of R512-E Coated C-103 Test Panel — Run Time: 4451 seconds — Start/Stop Cycles: 23*

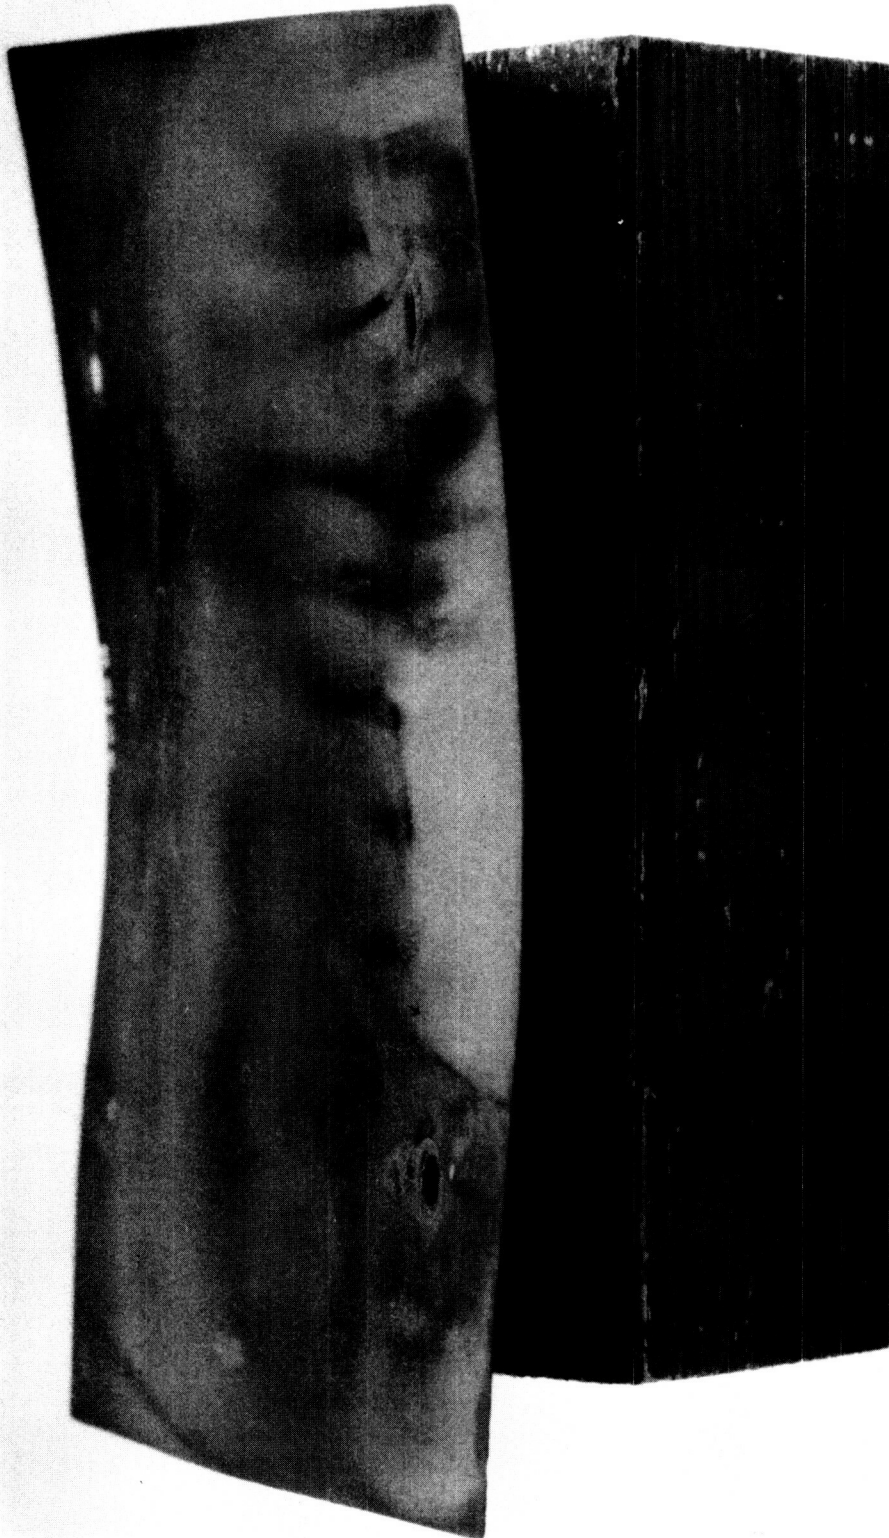
*Figure 3-27. Downstream View of R512E Coated C-103 Test Panel (Note the Cooling Tube Spacing Pattern Shown by the Surface Scale of the Panel)*

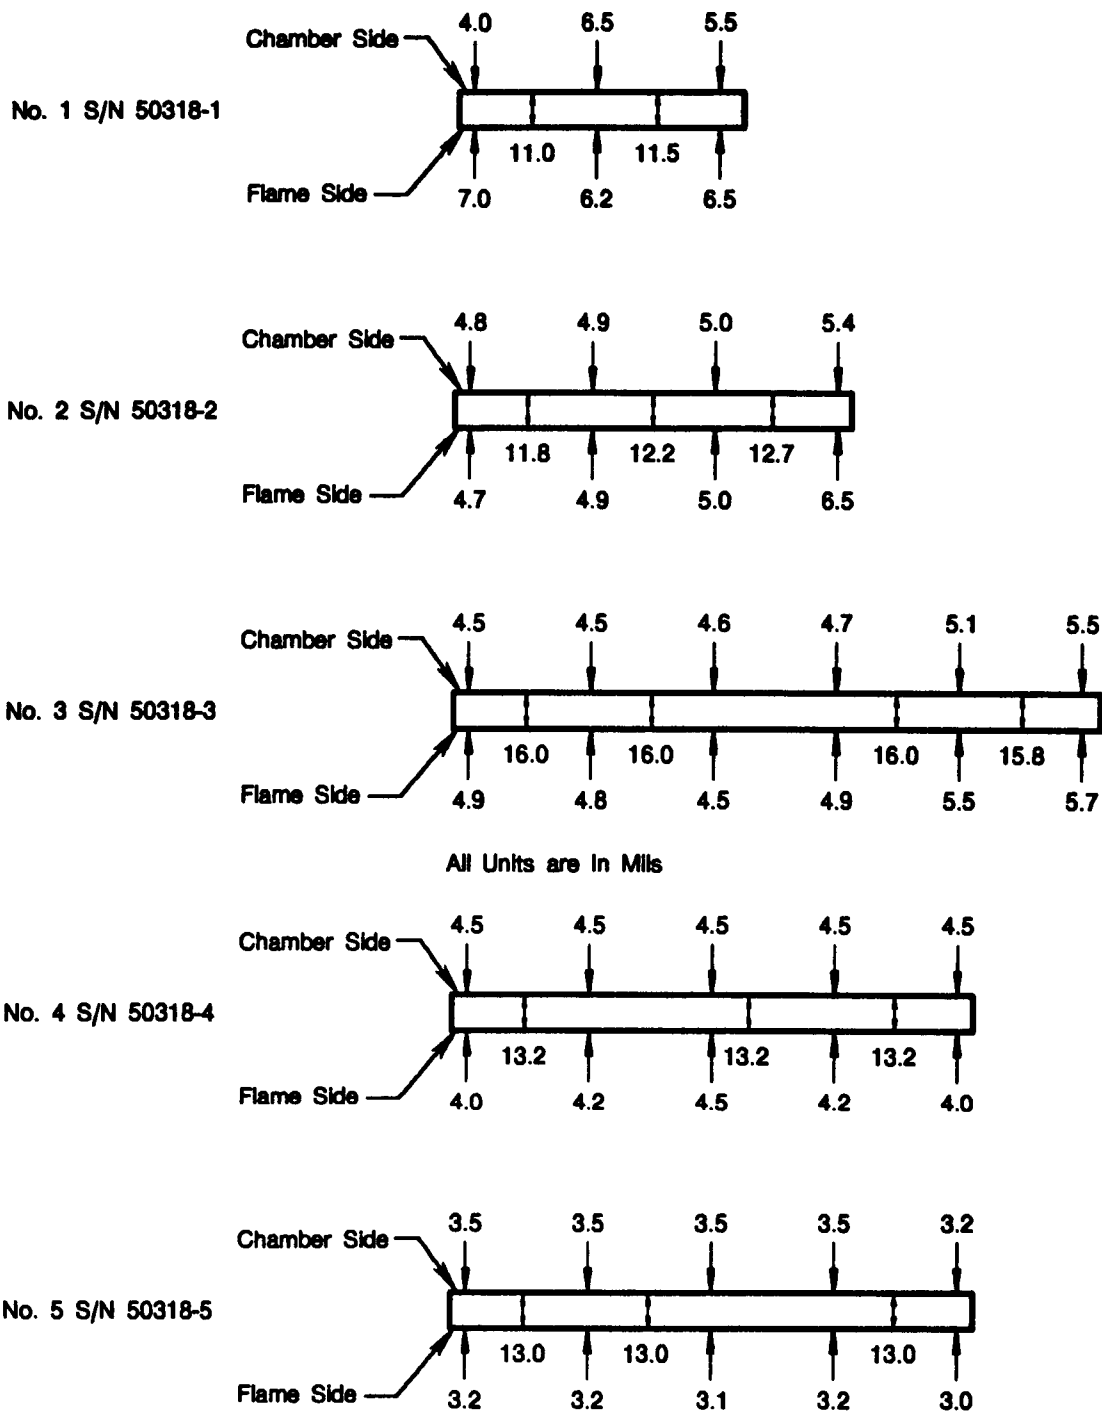
Figure 3-31. As-Coated R512-E Thickness Distribution of  $5.0 \pm 1.0$  mil Coating

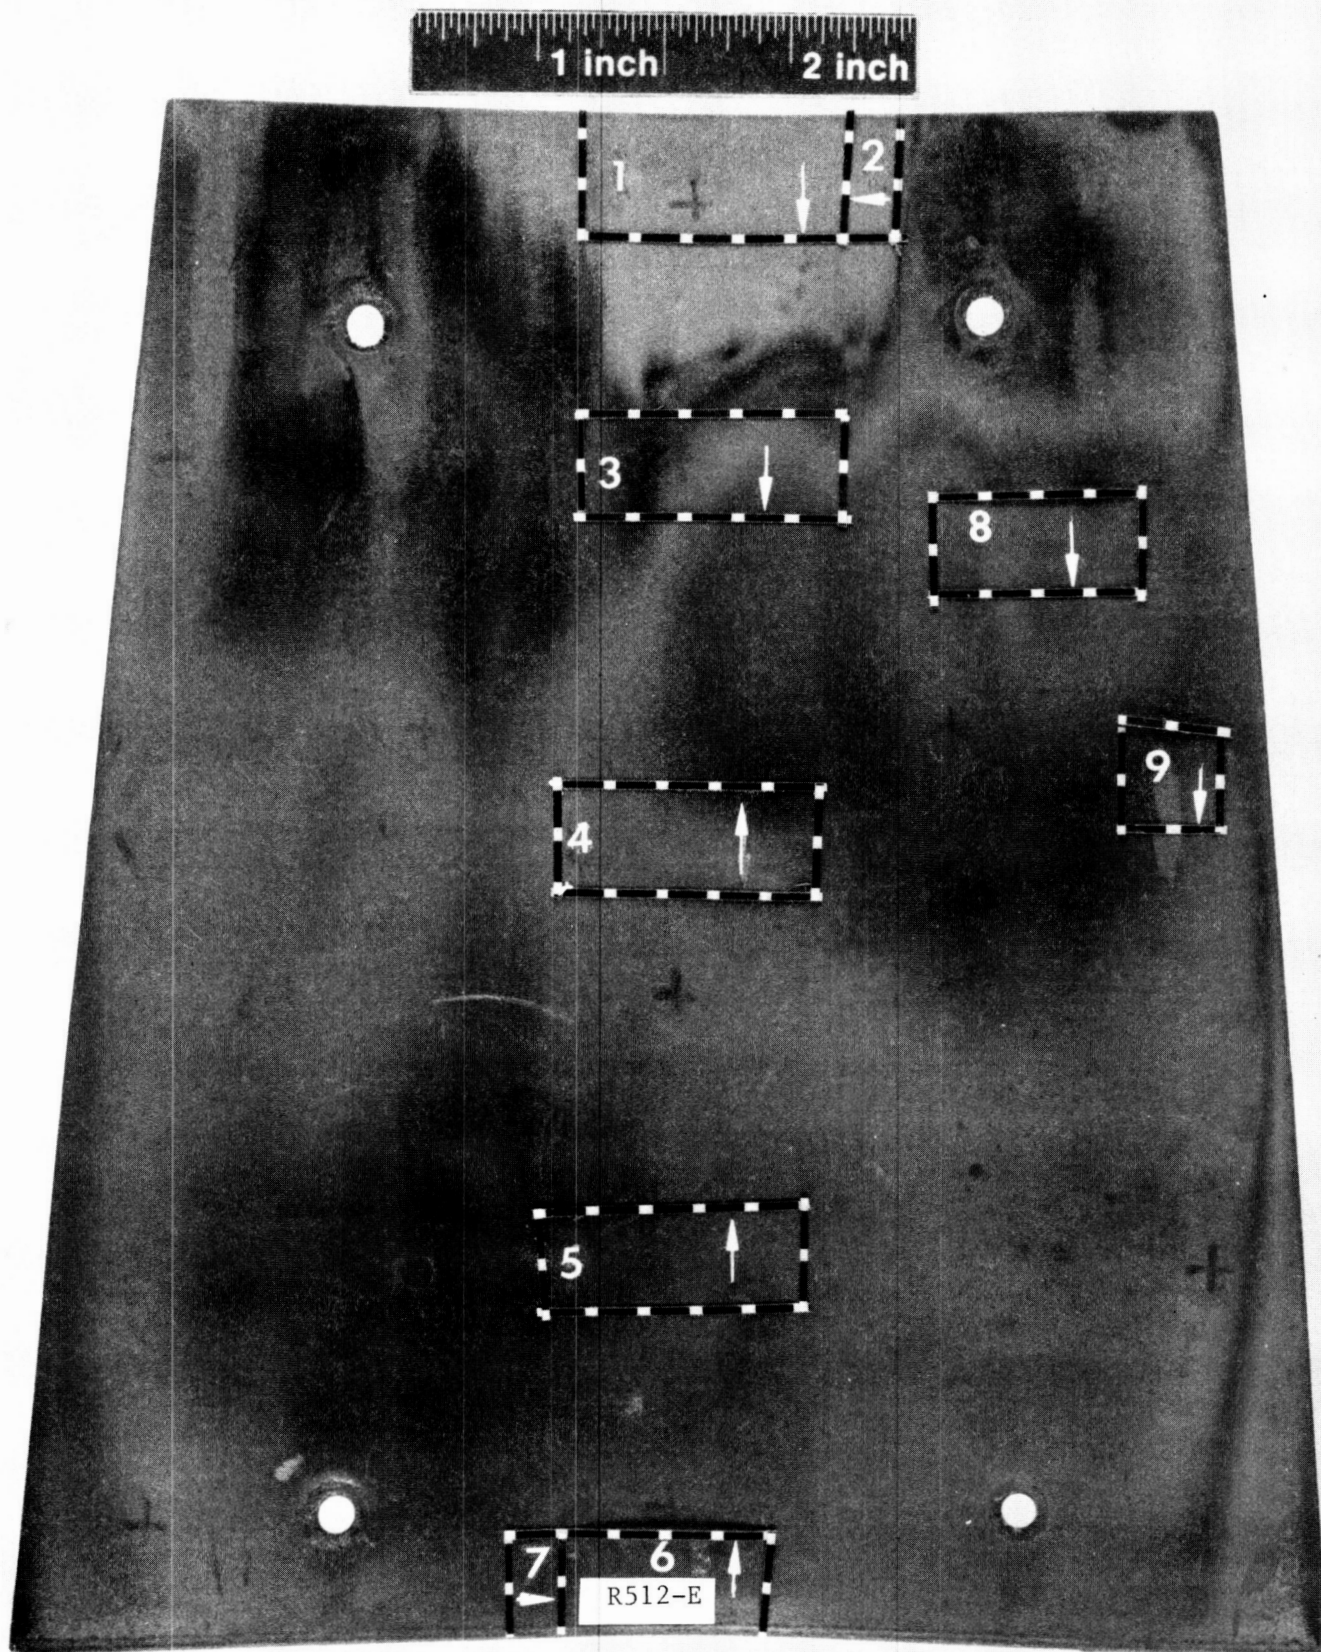
**Figure 3-32.** Sectioning Pattern of Gas Path (Flame) Side of R512-E Coated C-103 Test Panel — Run Time: 4451 seconds — Start/Stop Cycles: 23

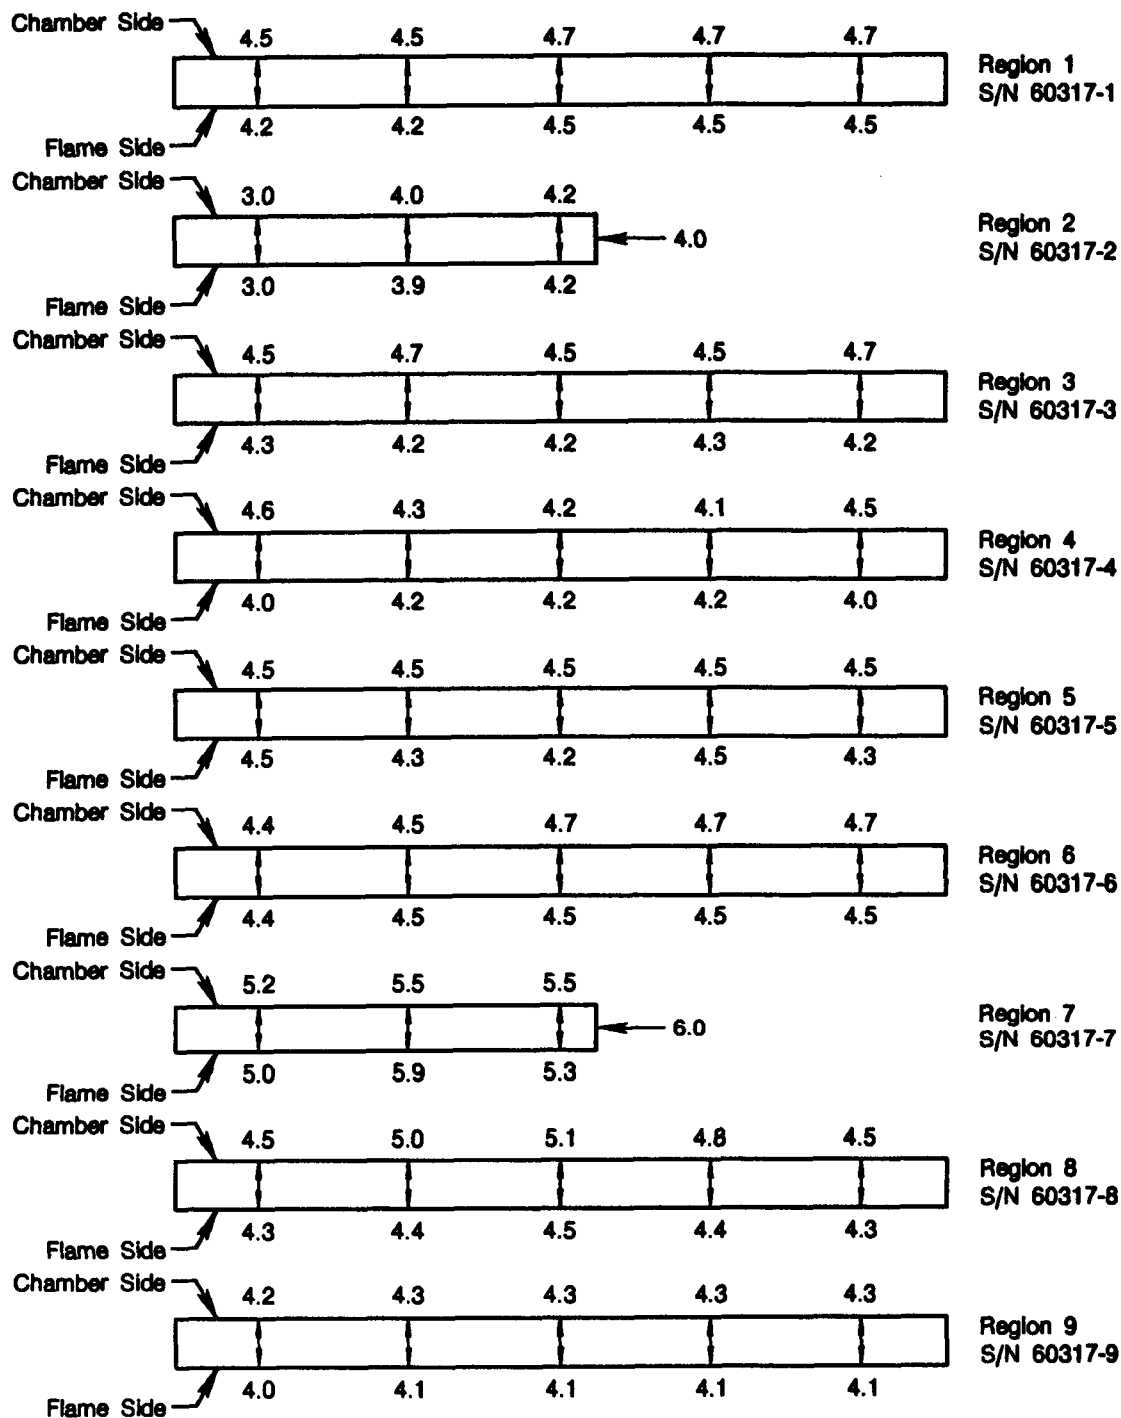
The first test of R512-E was conducted with a panel processed to a coating thickness of 3.1 mils as documented in Part I of this report. The bracket used for that test did not provide sufficient downstream support, and the panel experienced a low cycle fatigue failure. No additional panels with three mils of coating were available, therefore, a panel with five mils was used for this engine test evaluation. Previous analysis documents the coating/substrate thickness distribution for this panel in Figure 3-31. The initial coating thickness for R512-E averaged 4.5 mils with a standard deviation of 1.0 mil. Figures 3-32 and 3-33 display the sectioning pattern and the coating thickness distribution after engine testing respectively. The average coating thickness in Figure 3-33 was 4.4 mils with a standard deviation of 0.4 mil.

Figure 3-33. Coating Thickness Distribution Diagram of R512-E Coated C-103 Test Panel  
— Run Time: 4451 seconds — Start/Stop Cycles: 23

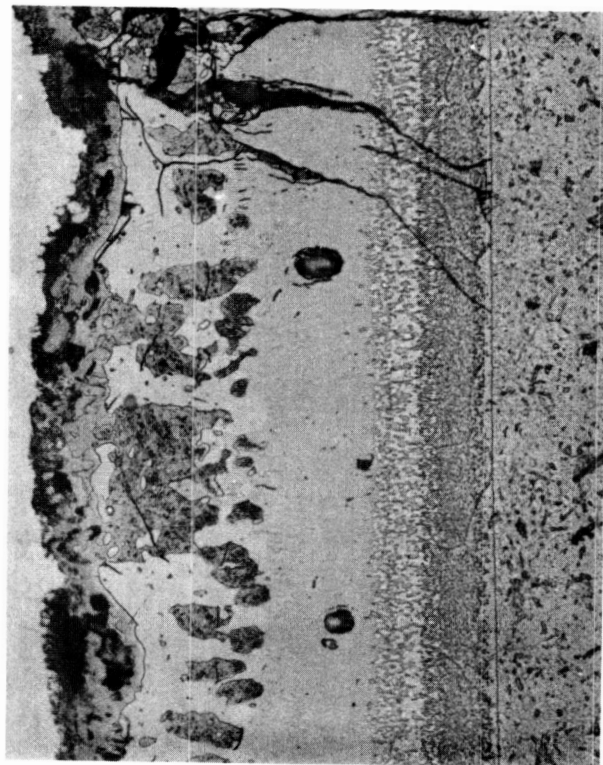
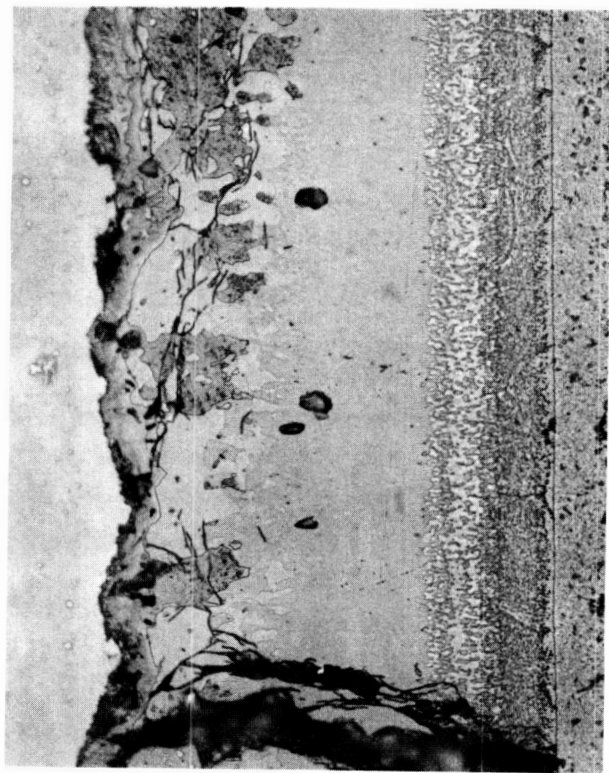
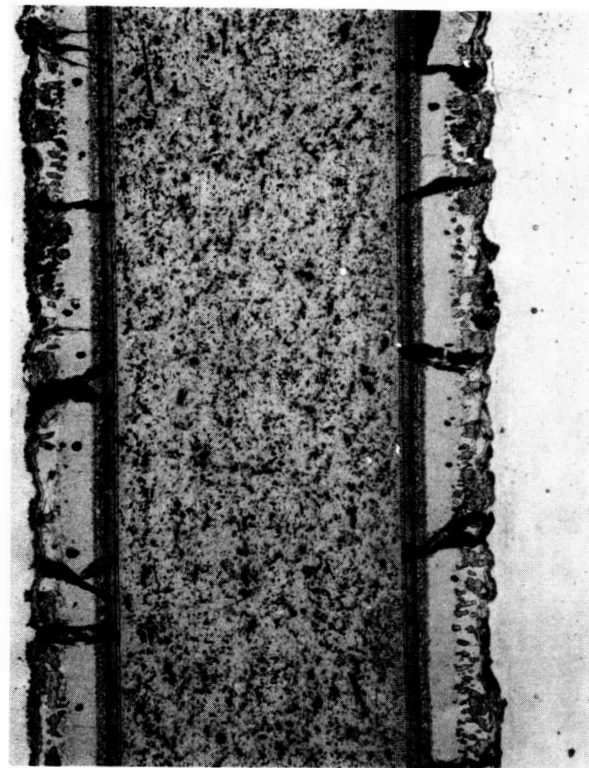
Review of the microstructures, progressing from the inlet plane of the extension to the exit plane of the extension, revealed no significant deleterious features (Figures 3-34 through 3-38). Changes in the original coating microstructure did occur. Thermal exposure allowed additional elemental partitioning. Thus, the composition of coating phases may have been slightly altered during engine exposure.

Figure 3-34. R512-E Coating Microstructure at Region 1 (S/N 60317-1) — Run Time: 4451 seconds — Start/Stop Cycles: 23

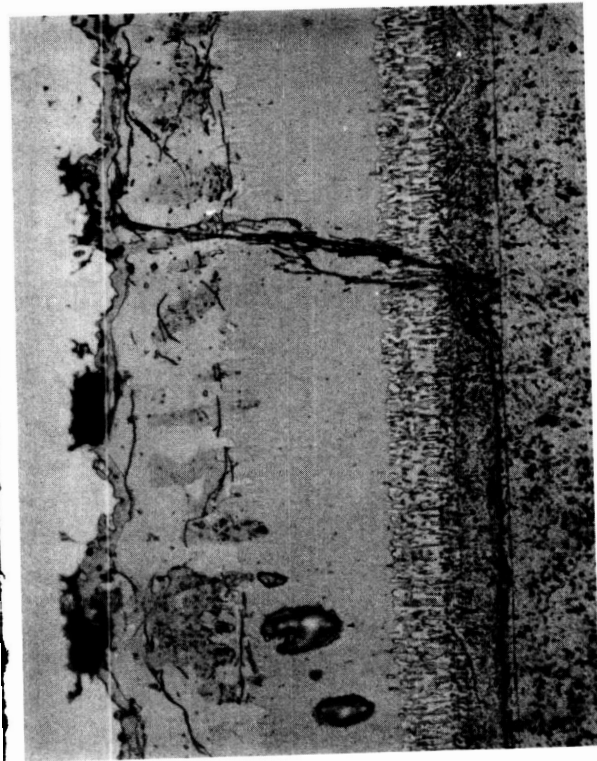
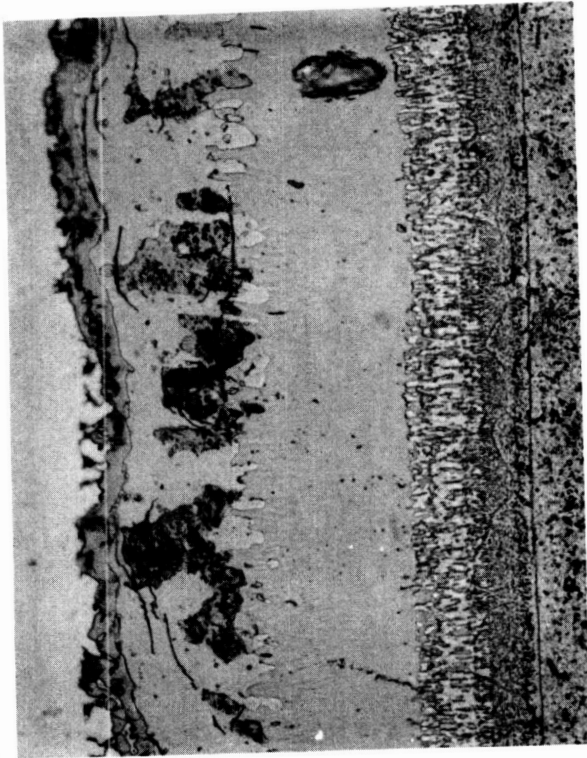
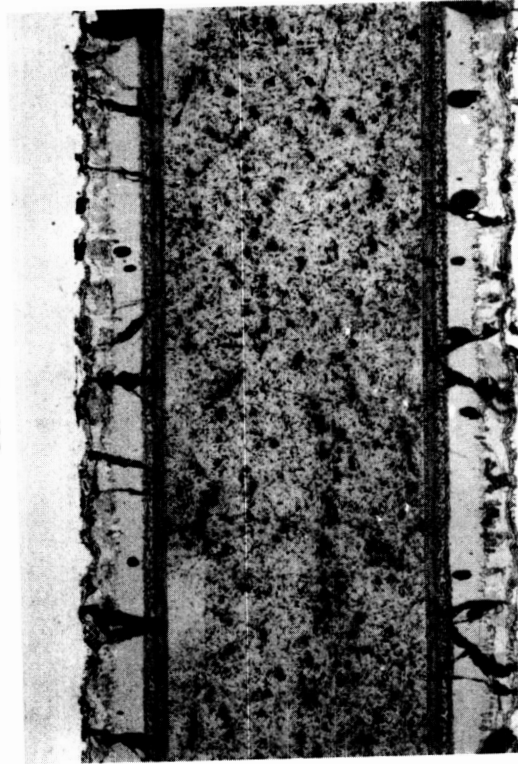
Figure 3-35. R512-E Coating Microstructure at Region 3 (S/N 60317-3) — Run Time: 4451 seconds — Start/Stop Cycles: 23
